***City of LaPorte Lakes
Aquatic Vegetation Management Plan-
Draft***

2008-2012

December 3, 2007

**Prepared by:
Aquatic Control, Inc.
PO Box 100
Seymour, Indiana 47274**

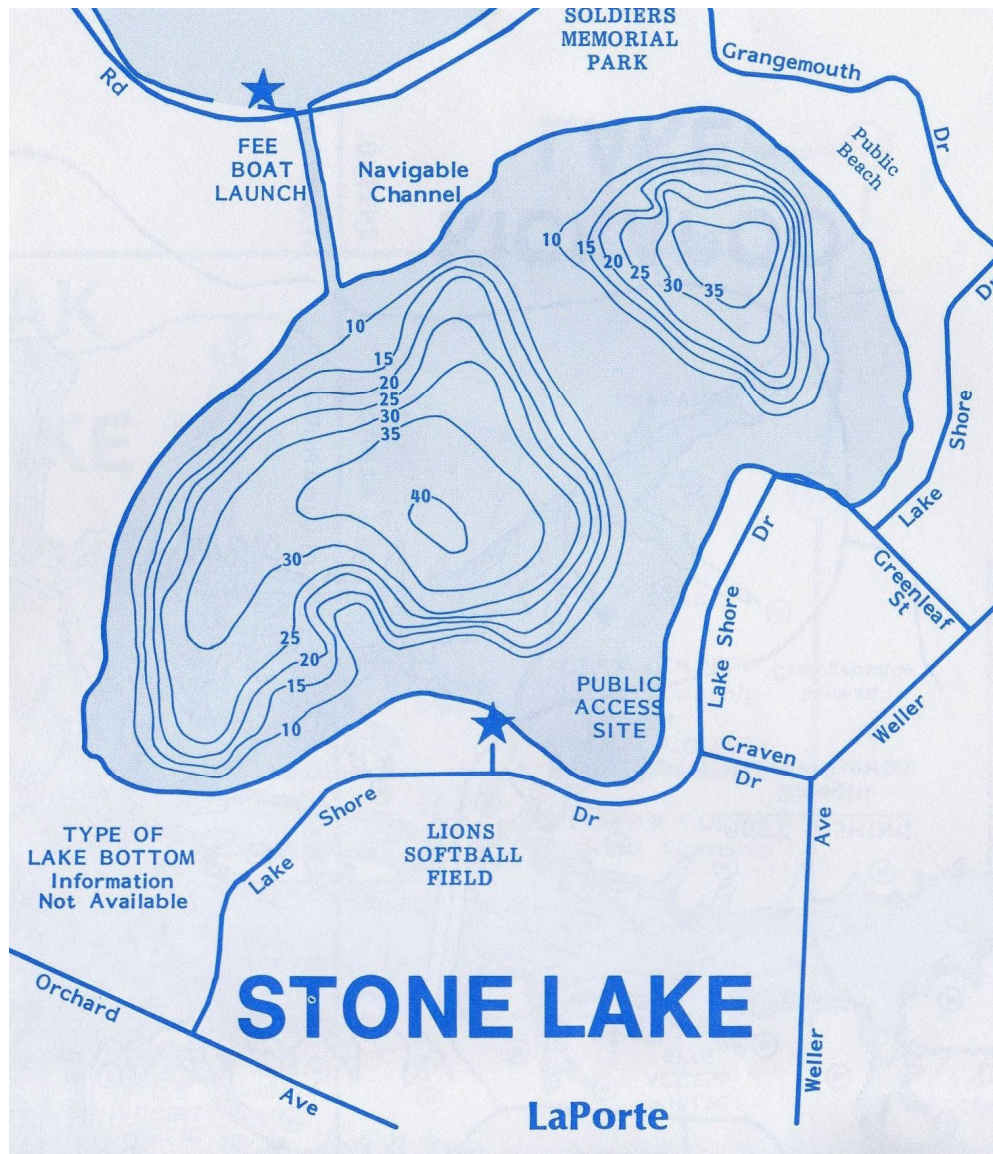
Figure 4. Stone Lake Bathymetric Map (Bright spot Maps 1999)

Stone Lake is connected to Pine Lake via a channel along Pine's southern shore. At 149 acres, Stone Lake is the second largest lake included in this plan. Stone Lake's watershed measures 1.41 square miles giving it a watershed to lake area ratio of 6.0. Stone Lake is classified as a Class I oligotrophic – mesotrophic lake. Stone Lake also exhibits excellent water clarity when compared to other Indiana Lakes. Secchi transparencies since 1975 have ranged from a low of 11.5 feet to a high of 22.0 feet (Baetis Environmental Services Inc. 2007). Clear water combined with large areas of shallow water, allows beneficial native vegetation to flourish in Stone Lake (Figure 4)

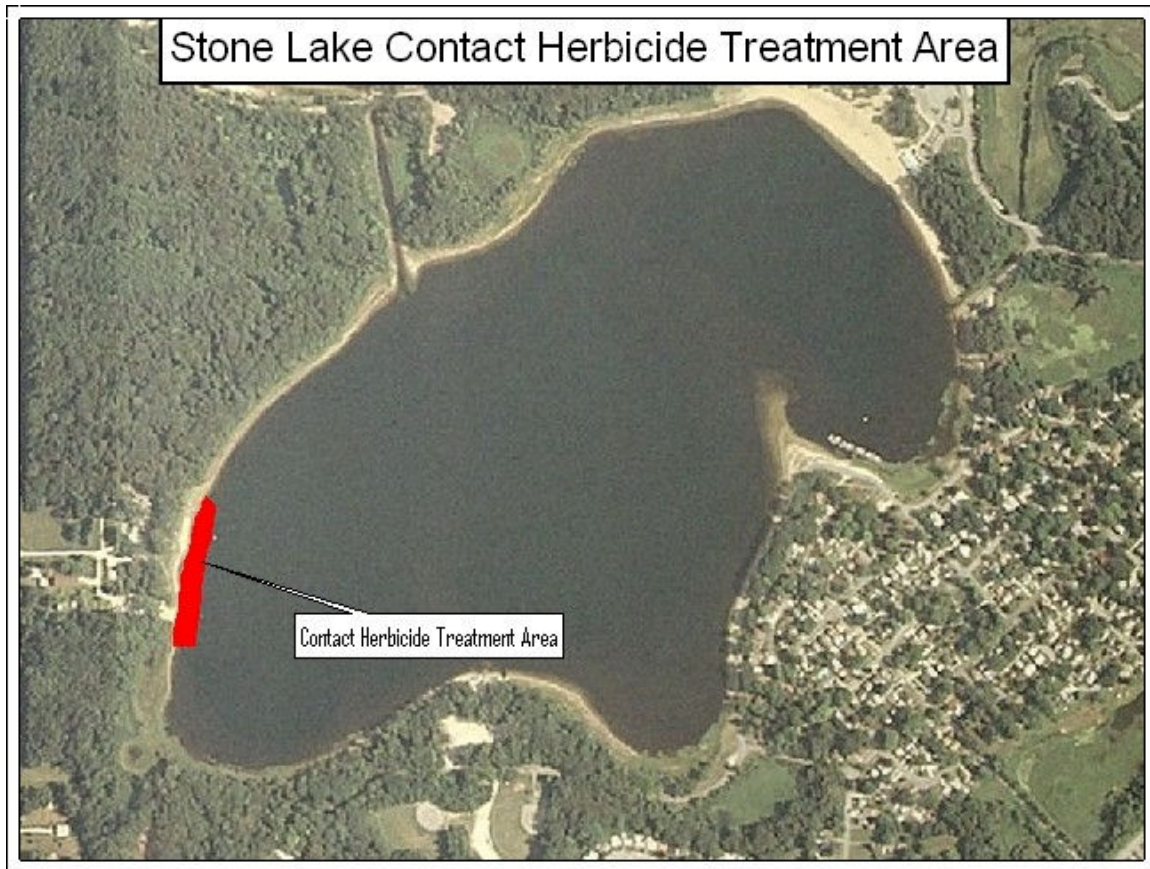
Figure 14. Stone Lake contact herbicide treatment area.

Very little vegetation management has been completed on Stone Lake due to the lack of development and the lack of substantial levels of nuisance invasive species. However, in 2005 and 2007, residents along the western shoreline contracted Aquatic Control to complete treatments to a 1.0 acre area along their docks (Figure 14). Treatments were completed using a combination of Reward and Nautique herbicides.

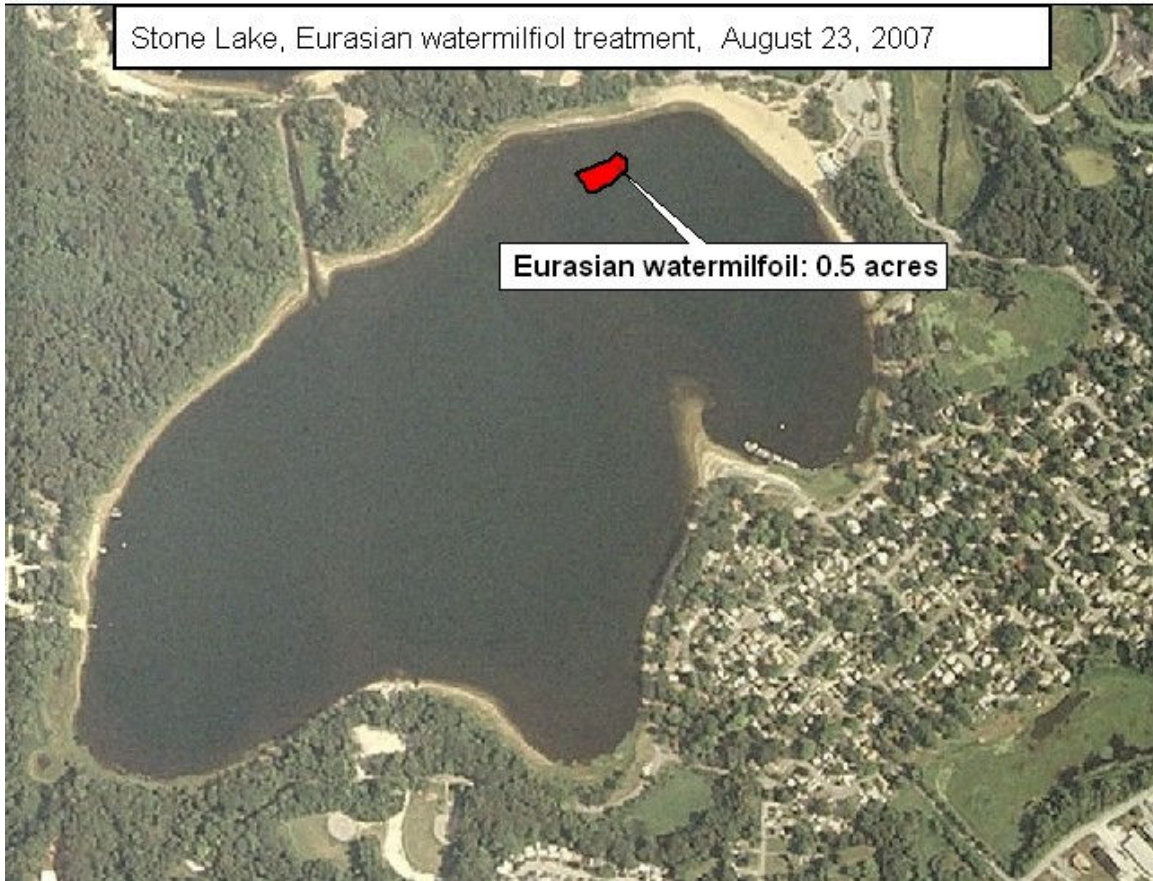
Figure 15. Stone Lake, Eurasian watermilfoil treatment area, August 23, 2007.

LARE and the LaPorte Parks department funded treatment of 0.5 acres of Eurasian watermilfoil on Stone Lake (Figure 15). This area was located during Invasive Species Mapping which was completed two weeks prior to the application. Treatment was completed on August 23 with Renovate OTF granular herbicide. A GPS was used in the application in order to insure accuracy.

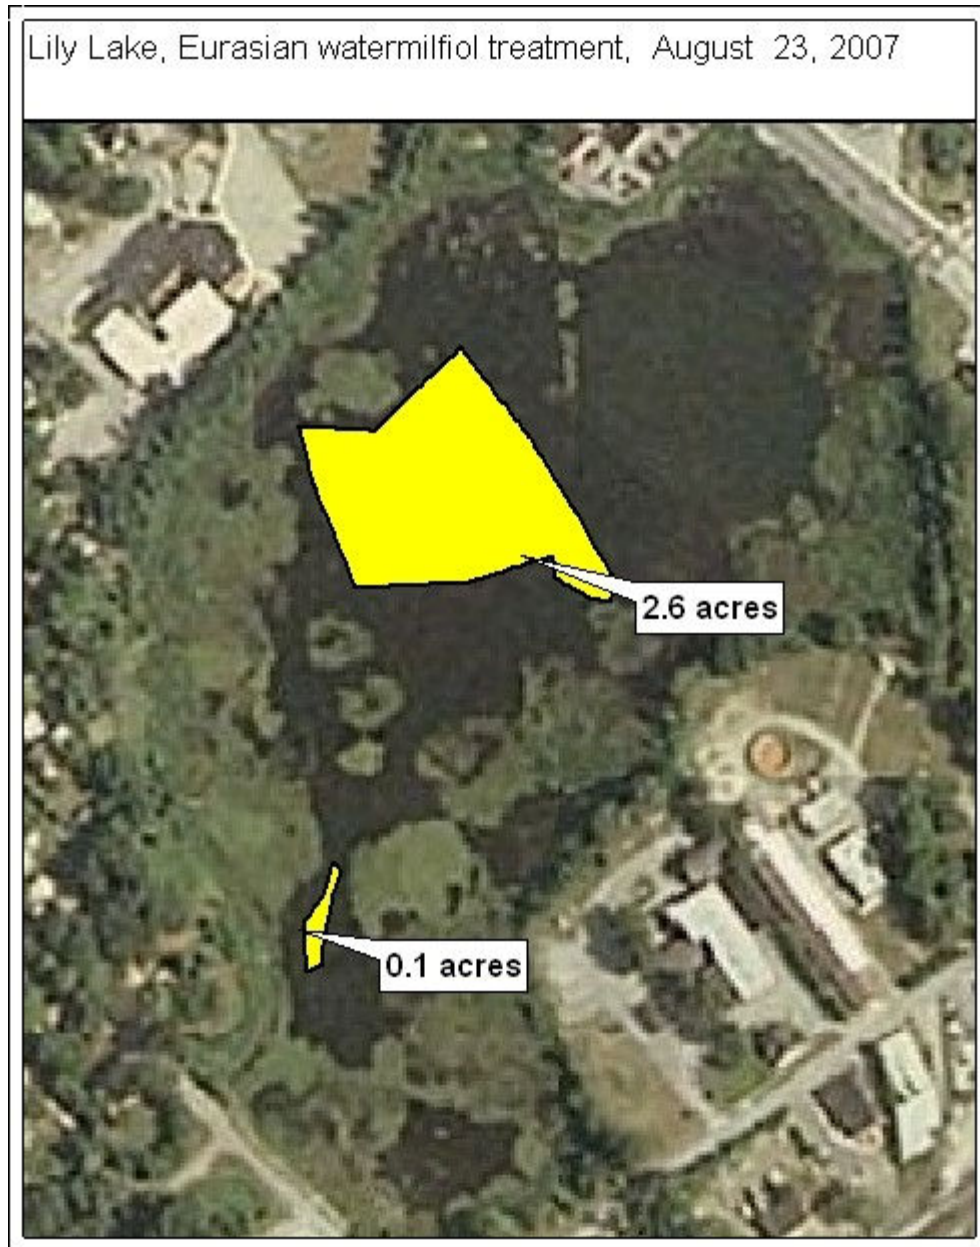
Figure 16. Lily Lake, Eurasian watermilfoil treatment areas, August 23, 2007.

There are no records of vegetation controls on Lily Lake prior to 2007. LARE and LaPorte Parks funded treatment of 2.7 acres of milfoil in 2007 (Figure 16). Areas for treatment were determined during the Invasive Species Mapping survey and on August 23 Renovate 3 herbicide was applied to these areas.

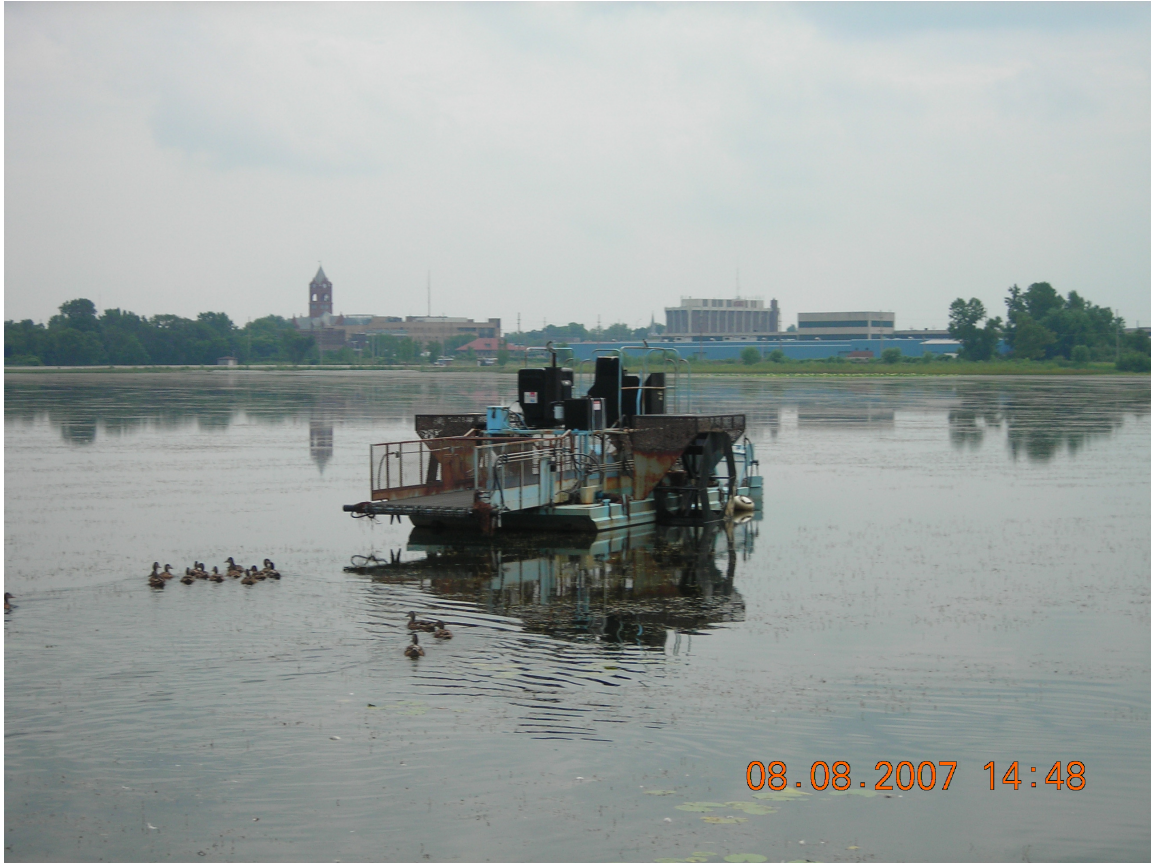
Figure 17. Clear Lake, photo of harvester, August 8, 2007.

levels present prior to the harvesting program. The current program may be removing phosphorus from Clear Lake and benefiting its water quality, but the machine produces fragments of Eurasian watermilfoil that can regenerate. This may be the reason watermilfoil is so evenly distributed across Clear Lake (Baetis Environmental Services 2007).

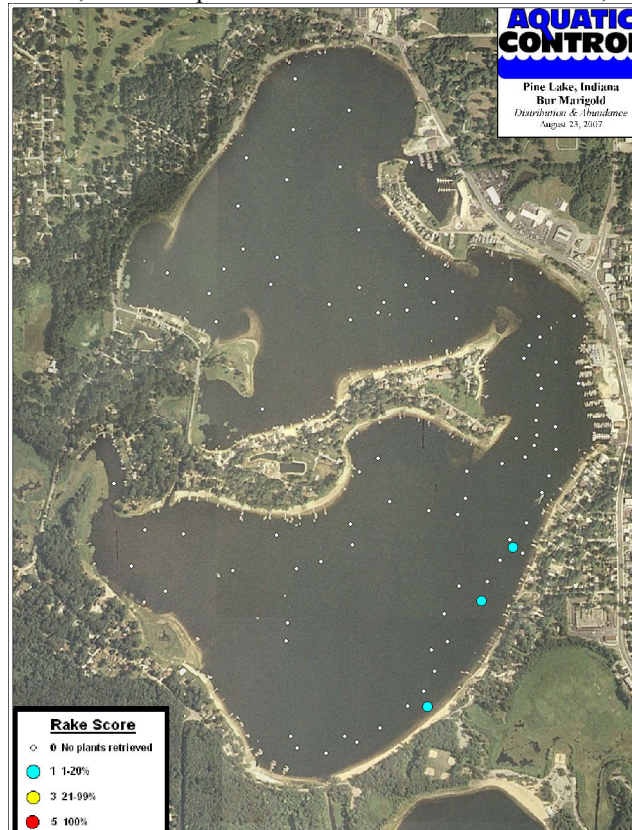
Figure 24. Pine Lake, bur marigold distribution and abundance, August 23, 2007.

Eel grass was collected at the highest percentage of sample sites (44.4%) and had the highest dominance index (27.1). Location and density of eel grass is illustrated in Figure 20. Common coontail ranked second in frequency (30.0%) and dominance (17.6). Eurasian watermilfoil was the only non-native species collected and it was tied for third in frequency (14.4%) and ranked fifth in dominance (10.2) (Figure 21). Variable pondweed, northern watermilfoil, whitestem pondweed, slender naiad, American elodea, flatstem pondweed, and Robbin's pondweed all occurred at 10% or more of sample sites. Whitestem pondweed is considered state threatened. It occurred at 21.1% of sample sites and its location and density is illustrated in Figure 22. Robbin's pondweed is considered to be rare in Indiana, but it occurred at 10.0% of sample sites in Pine Lake (Figure 23). Bur marigold, a state threatened species, was collected at only two sites (Figure 24).

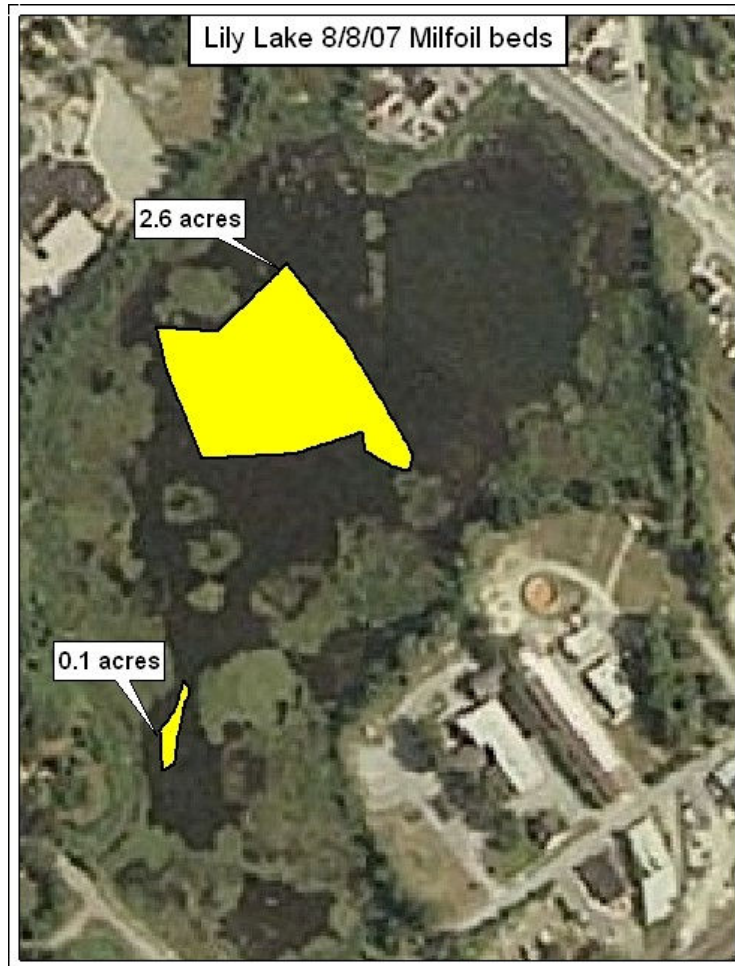
Figure 33. Lily Lake Eurasian watermilfoil location, August 8, 2007

The Invasive Species Mapping Survey was completed on August 8, 2007. Invasive species mapping located 2.7 acres of Eurasian watermilfoil (Figure 33.) These were not especially dense milfoil beds as common coontail was more abundant in these areas than milfoil.

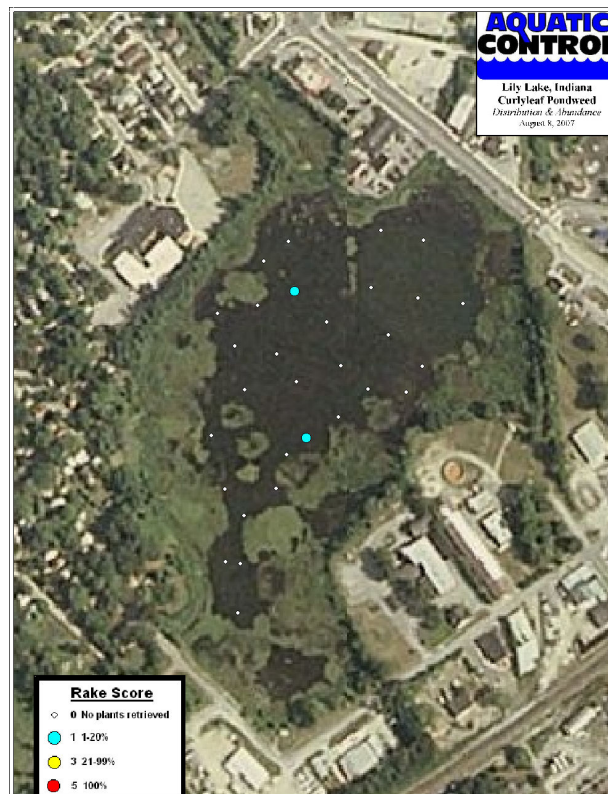
Figure 36. Lily Lake, curlyleaf pondweed distribution and abundance, August 8, 2007.

Common coontail was collected at the highest percentage of sample sites (83.3%) and had the highest dominance index (66.7). Location and density of coontail is illustrated in Figure 34. Brittle naiad ranked second in frequency (56.7%) and dominance (35.3) followed by Eurasian watermilfoil which occurred at 50% of sites (Figure 35). Small pondweed and sago pondweed were each collected at 10% of samples sites while slender naiad was present at only 6.7% of sites. Curlyleaf pondweed was the only other non-native species collected and it was found at 6.7% of sites (Figure 36).

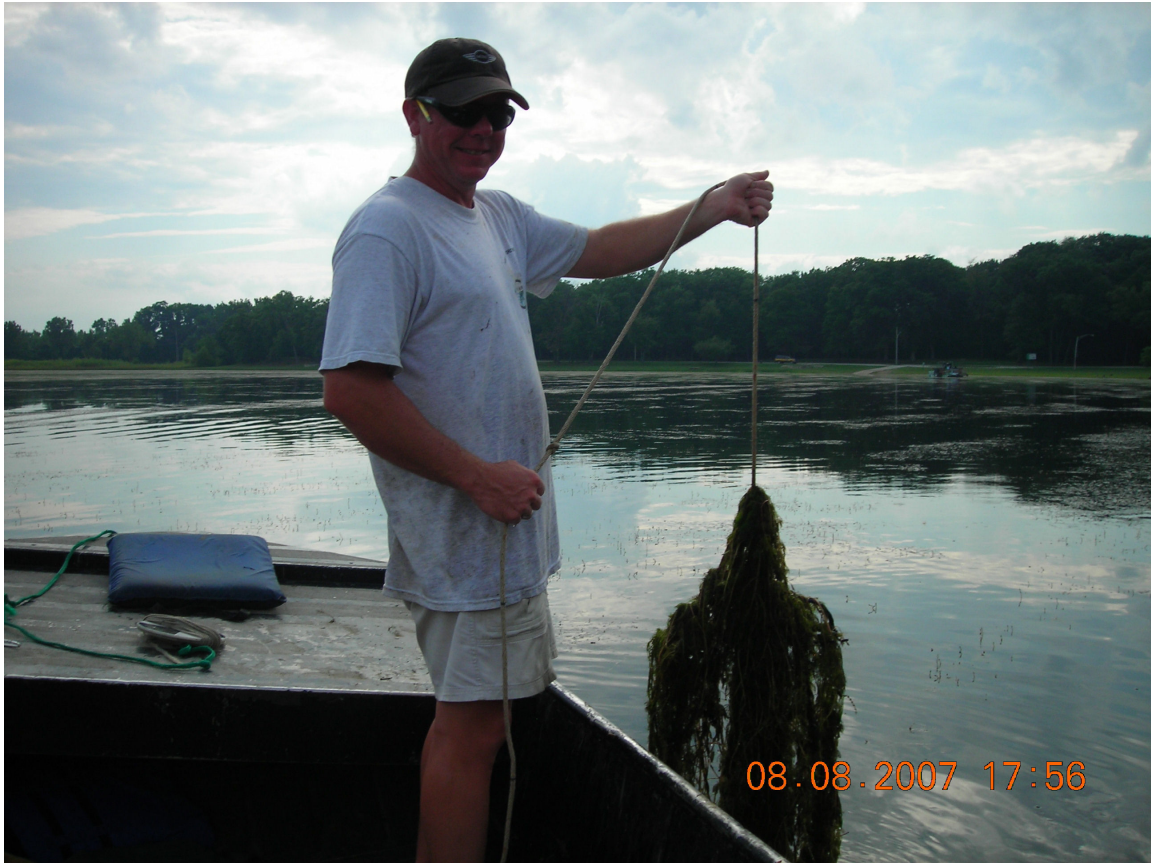
Figure 39. Clear Lake, typical Eurasian watermilfoil dominated rake haul.

Eurasian watermilfoil was collected at every site and had a rake score of five at all but four sites (Figure 39). Location and density of Eurasian watermilfoil is illustrated in Figure 40. Common coontail ranked second in frequency (48.0%) and dominance (21.6). and location and density is illustrated in Figure 41. Brittle naiad ranked third in frequency (Figure 42) followed by small pondweed, Illinois pondweed, slender naiad, water stargrass, and American elodea.

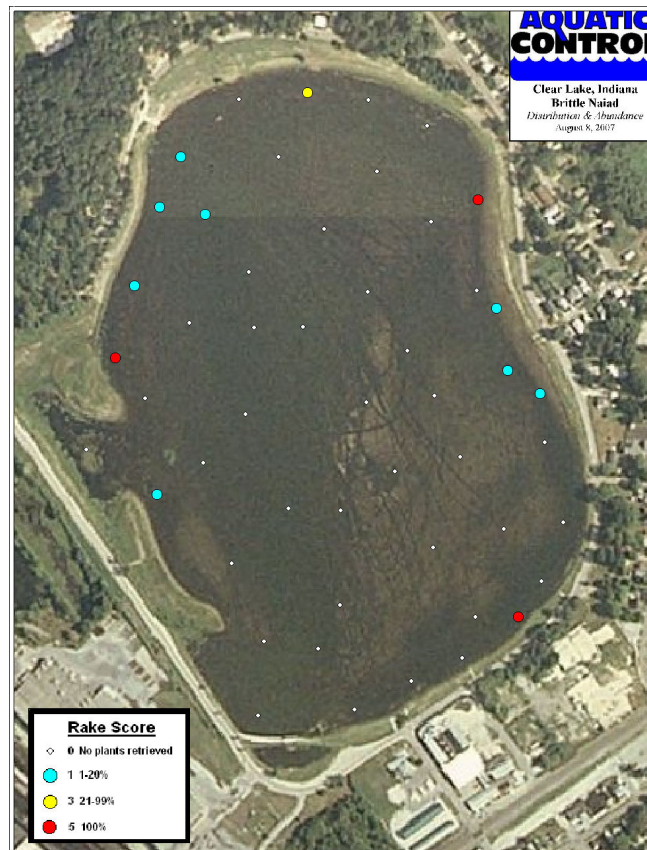
Figure 42. Clear Lake, brittle naiad distribution and abundance, August 8, 2007.

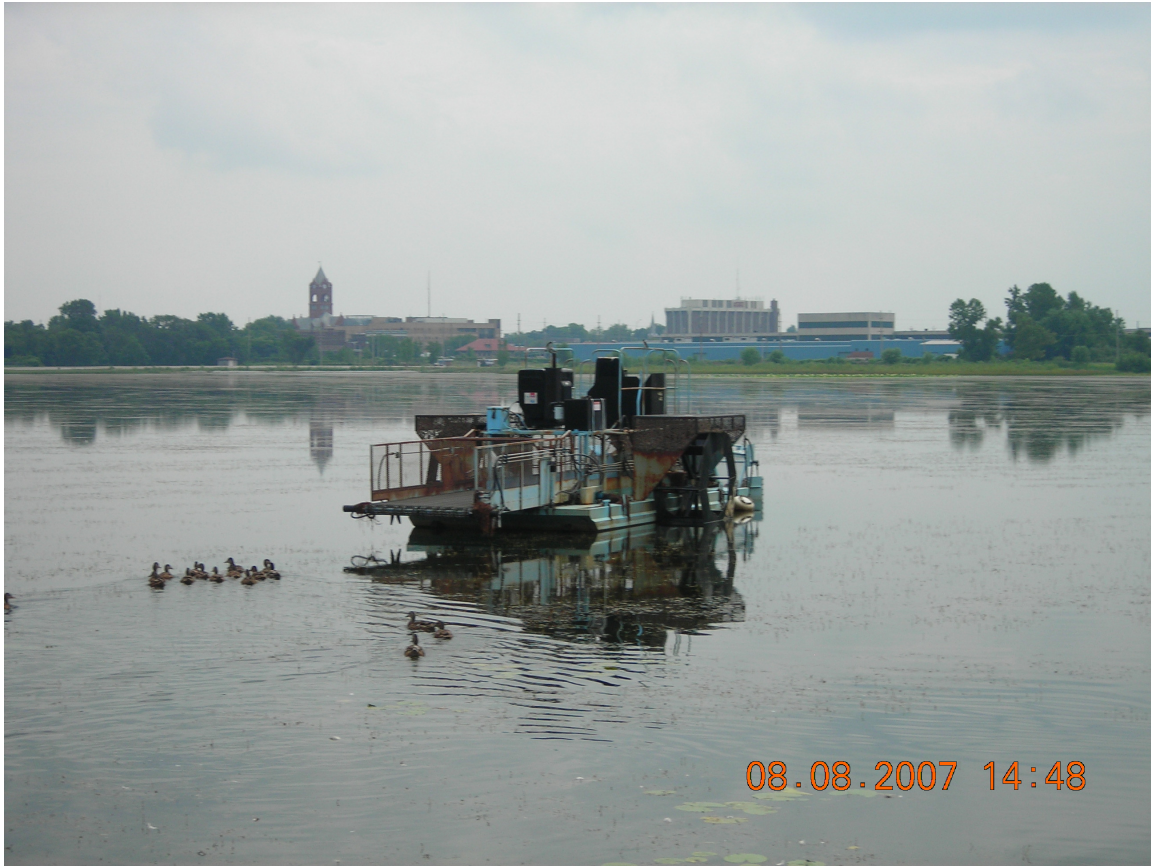
Figure 43. Picture of a harvester sitting in middle of milfoil bed.

One of the most common mechanical control techniques used on larger lakes in Indiana is mechanical harvesting. Mechanical harvesting uses machines which cut plant stems and, in most cases, pick up the cut fragments for disposal. This type of mechanical control has little selectivity. Where a mix of Eurasian watermilfoil and native species exists, harvesting favors the plant species that grow back most rapidly following harvesting. In most cases, Eurasian watermilfoil recovers from harvesting much more rapidly than native plants. Thus, repeated harvesting hastens the replacement of native species by Eurasian watermilfoil and often leads to dense monocultures of Eurasian watermilfoil in frequently harvested areas (Figure 43). Harvesting also stirs up bottom sediments thus reducing water clarity, kills fish and many invertebrates, and hastens the spread of Eurasian watermilfoil via fragmentation.
